## #PI0756B: Retrofit Procedure for New Corded Folding Top Cover Installation to Original Design Frame - (Dec 4, 2012)

**Models:** 2011-2012 Chevrolet Camaro Convertible

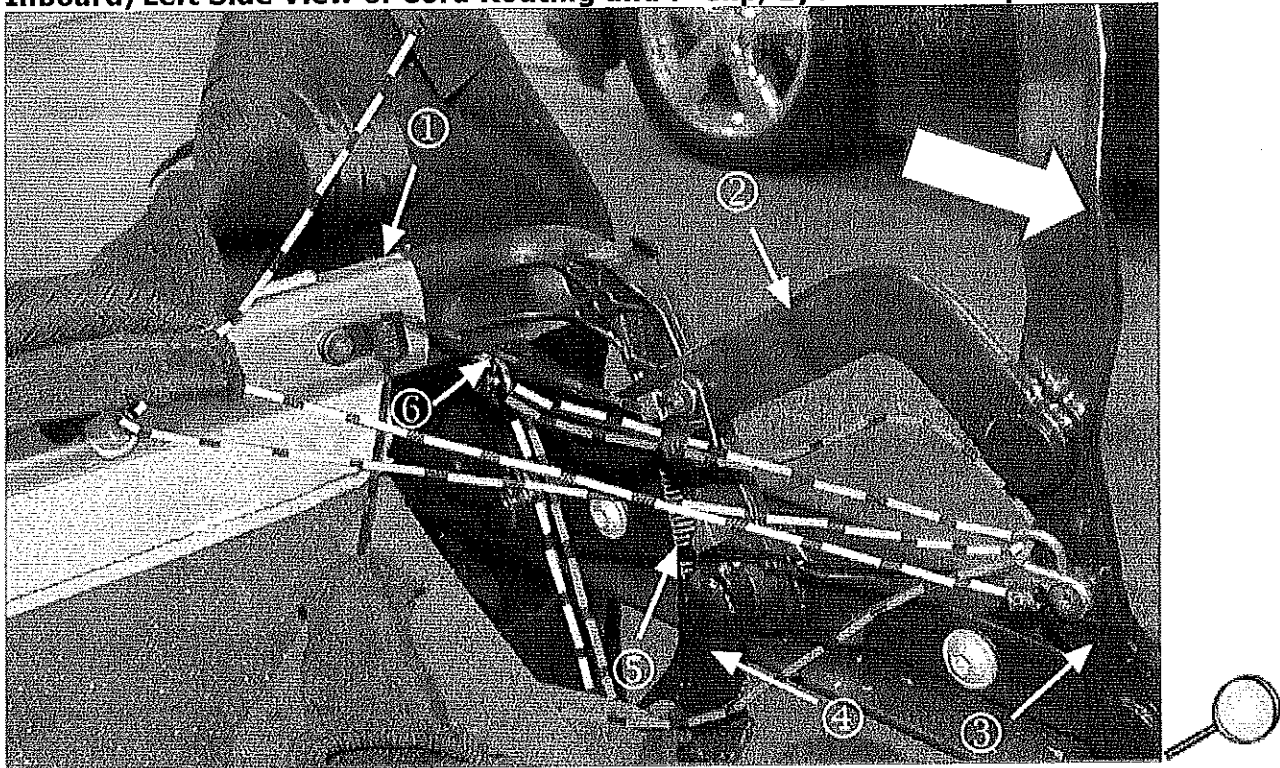
**Inboard/Left Side View of Cord Routing and P-Clip, Eyelet and Straps Orientation**

**Note:** The graphics above are views with the top in mid-open position and the right side views would mirror the left. The top frame links and strap callouts referenced later in the instructions are noted in the key below.

**Key to Call-outs Noted Above**

- (1) #2 Bow
- (2) Control Link

- (3) Rear #1 Bow Link
- (4) Balance Link
- (5) Headliner Strap
- (6) Rear Top Cover Strap

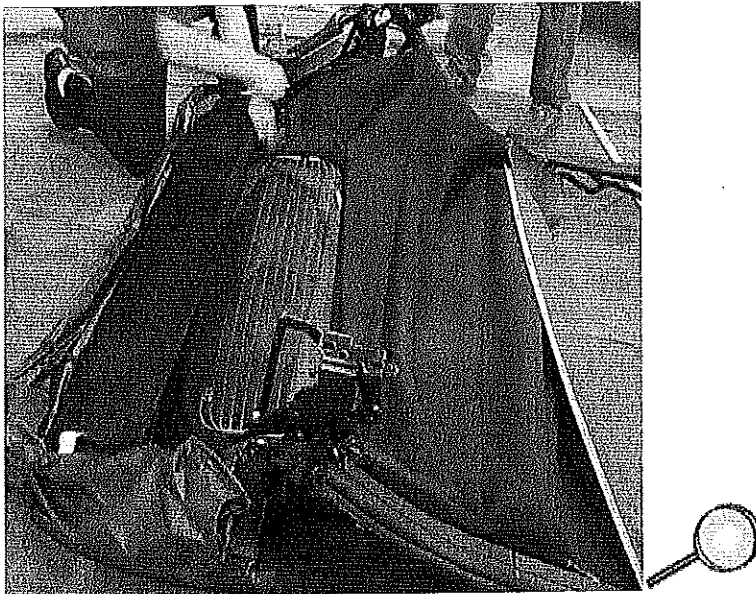
2. Place the convertible top on a clean tarp or other clean, dry, suitable surface with the top cover facing downward as shown above.

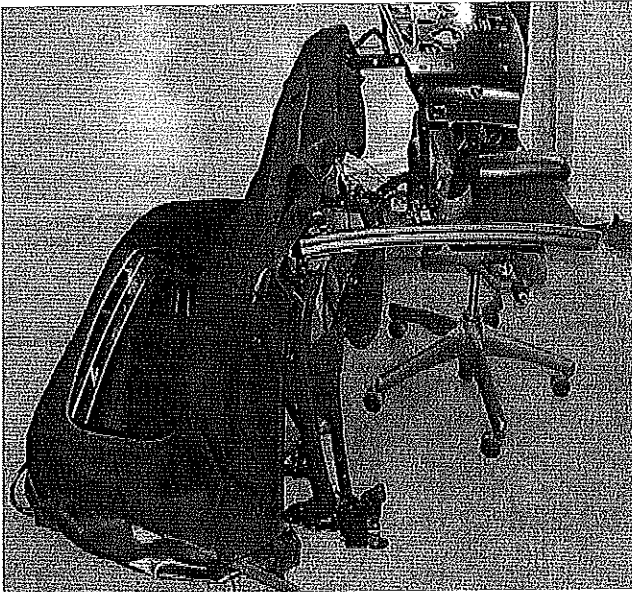
5. Position the folding top on the floor, sitting upright in the mid-open position with the #1 bow supported by a suitable support as shown above.

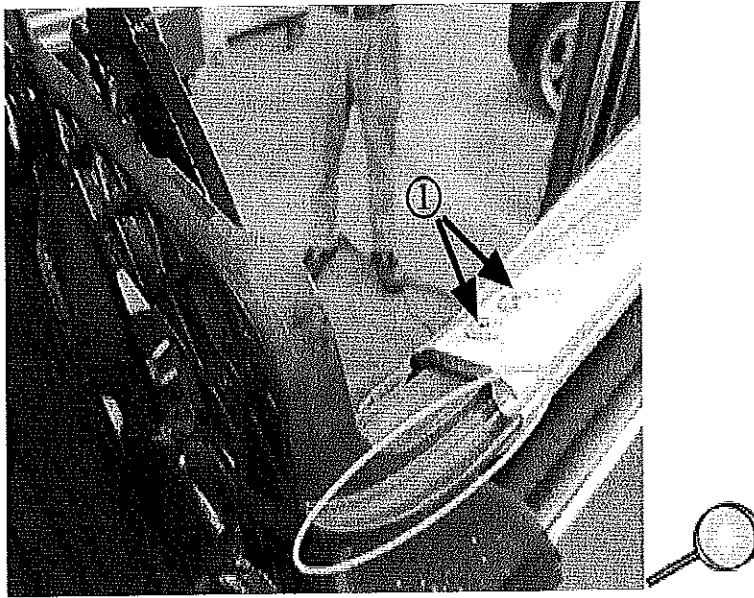
#### **Early Design #2 Bow Bracket**

**Important:** The #2 bow end brackets are made of plastic and will likely break/snap during removal. Two new brackets are included with the top cover replacement kit. Regardless of breakage, all early design #2 bow brackets should be replaced.

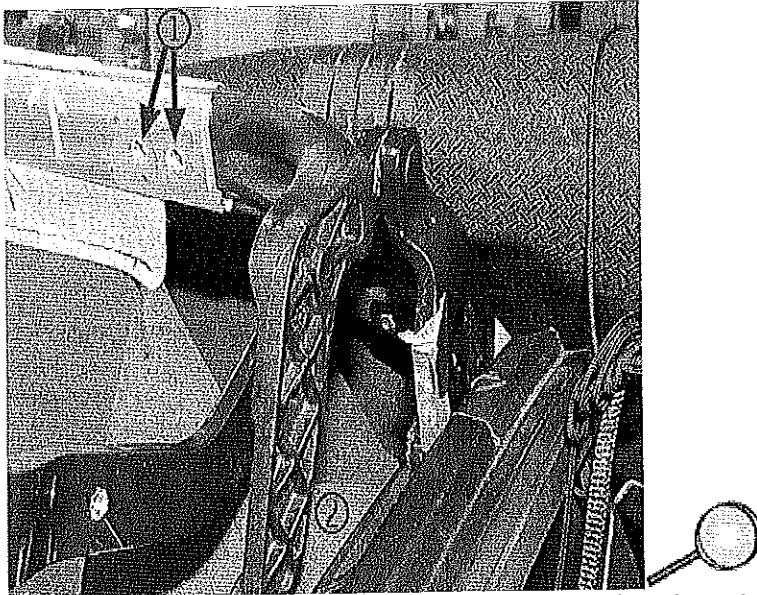
- 10.1. Drill out the rivets (1) that hold the #2 bow brackets to each end of the #2 bow (two rivets per side), and remove the D-link from the headliner cord on each side.

- 10.2. If still attached, slide the headliner retaining bead out of the #2 bow and drill out the rivet (2) retaining the side headliner straps to each side #2 bow bracket.

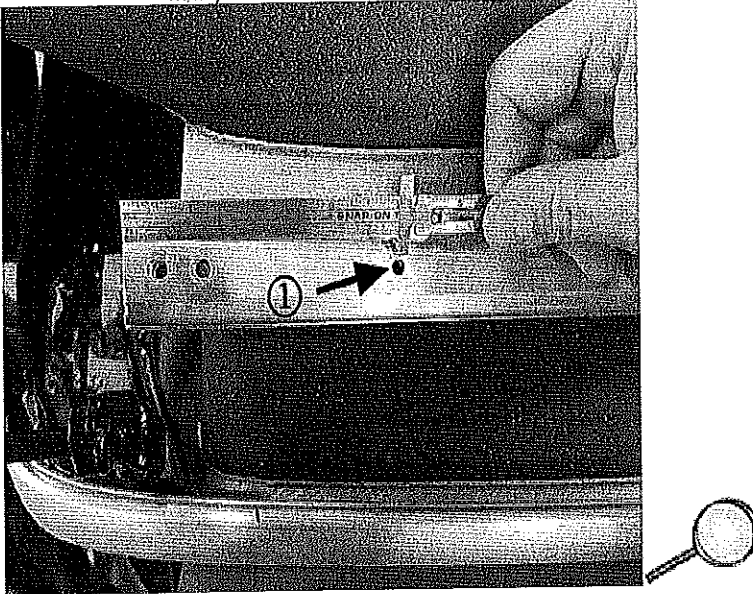
**Important:** The two holes added to the #2 bow should be centered on the bow and ARE NOT through holes. DO NOT drill through to the topside of the #2 bow.

11. While the #2 bow is removed, drill two 5 mm (0.197 in) holes (1) in the underside of the #2 bow. Position the holes 102 mm (4.0 in) from each end of the bow.

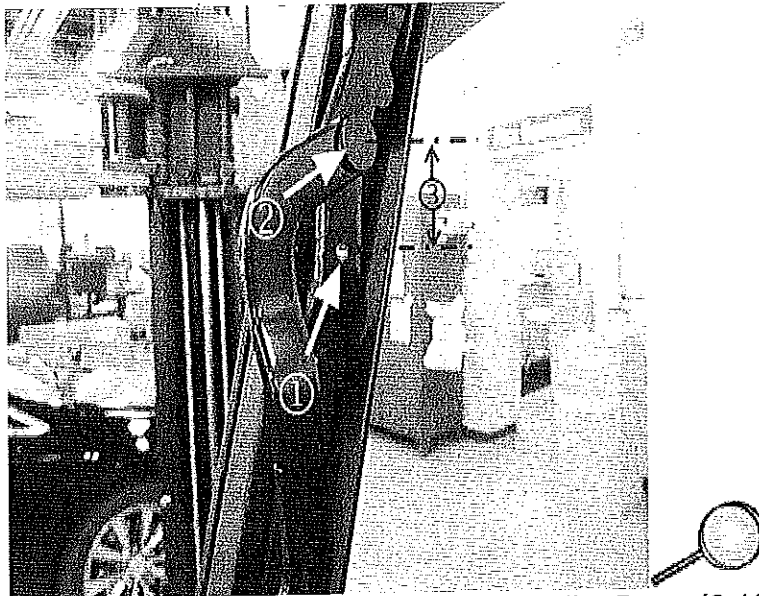
12. Centered on the left rear #1 bow link, drill a 5 mm (0.197 in) hole (1) into the link, positioned 35 mm (1.375 in) (3) from the center of the link pivot (2). Repeat the same operation on the opposite side of the top.

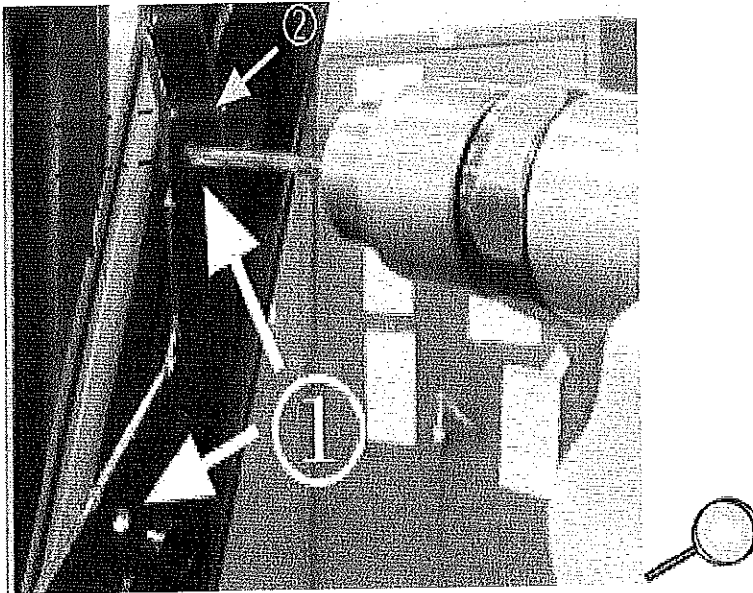
**Note:** Older convertible tops may be missing the upper 3.2 mm diameter hole shown in the control link above. If the hole is missing, add by drilling a new 5 mm (0.197 in) hole positioned 10 mm (0.40 in) (3) from the bend radius (2). Repeat the same operation on the opposite side of the top.

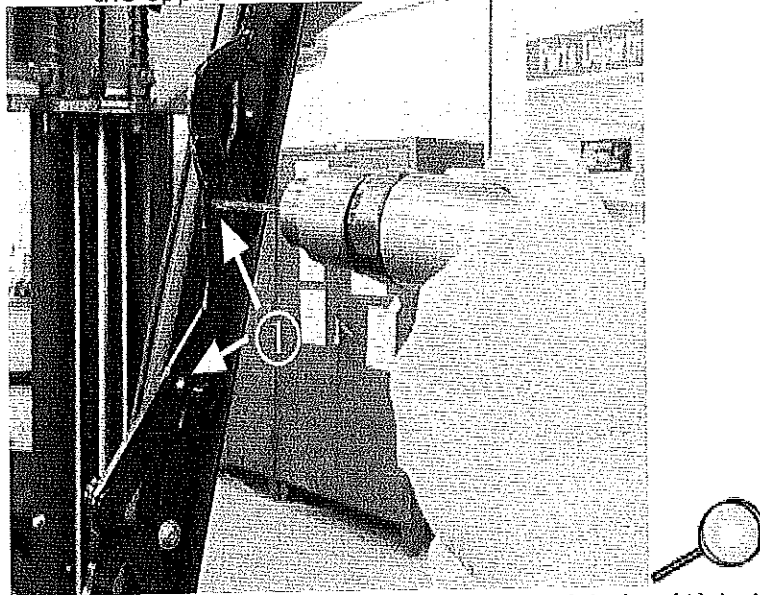
13. Re-drill the two existing 3.2 mm (0.125 in) holes (1) in the left control link to open the diameter up to 5 mm (0.197 in). Repeat the same operation on the opposite side.

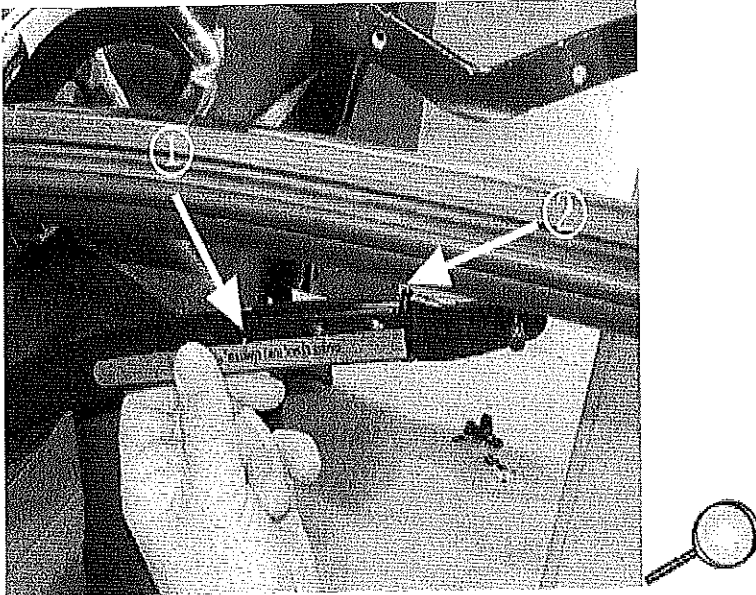
**Important:** The holes added to the each balance link are on the outboard side of the link and ARE NOT through holes. DO NOT drill through to the inboard side of the balance link. The right side balance link is shown in the graphic above.

14. Centered on the outboard side of the right balance link (1), drill a new 3.2 mm (0.125 in) hole, positioned 80 mm (3.15 in) from the center of weld bead (2). Repeat the same operation on the opposite side.

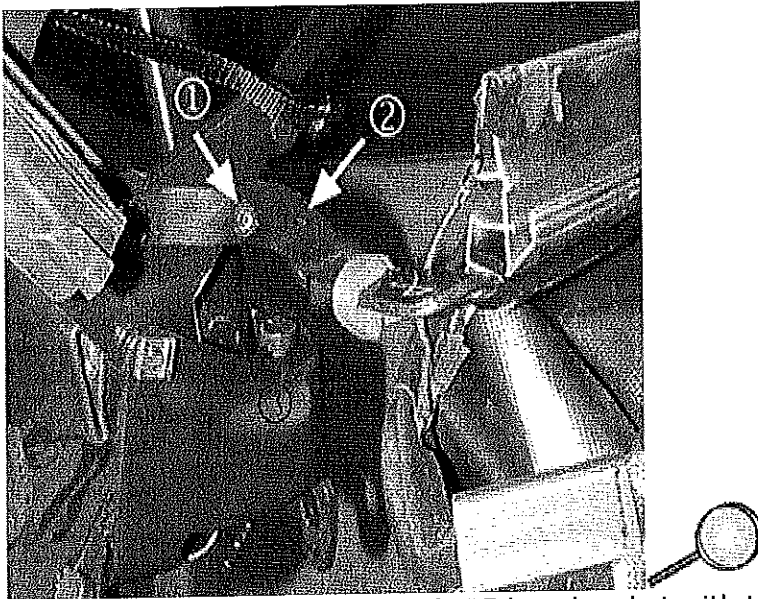
15. The graphic above shows the left #5 bow bracket with the strap and cords removed, and also the orientation of the new hole (1) and existing hole (2) for illustration purposes only.
  - 15.1. Drill a 5 mm (0.197 in) hole into the left and right #5 bow brackets, positioned 30 mm (1.12 in) (3) from the hole where the rear headliner strap and water management bag cord are attached.
  - 15.2. Drill out the original rivet retaining the strap and cord for repositioning those to the new hole.

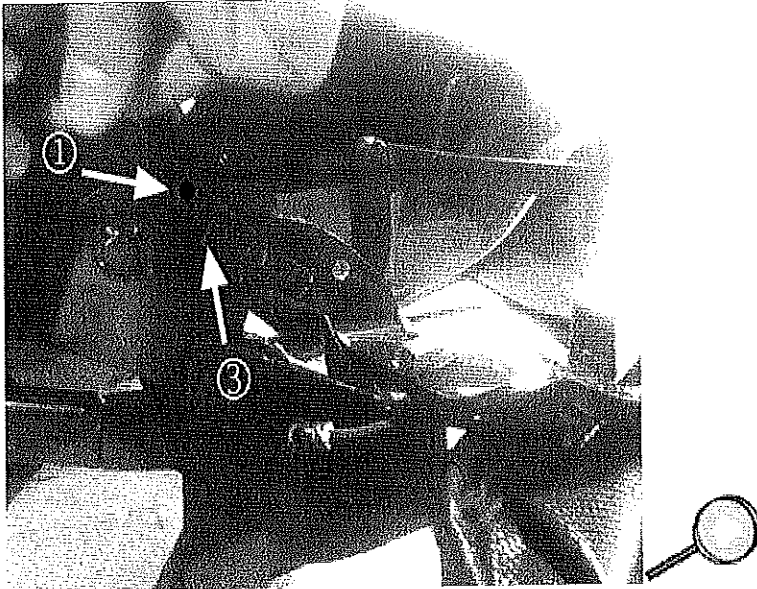
- 15.3. The graphic above shows the headliner strap, which is attached to the 5 bow bracket. If the top being retrofitted does not have a new 5 bow bracket equipped with the new hole, then using a hot mandrel, or equivalent tool, burn a new hole (1) into the headliner strap. As shown above, locate the new hole 30 mm (1.20 in) (2) from the current location, then cut the reworked headliner strap at call out #3.

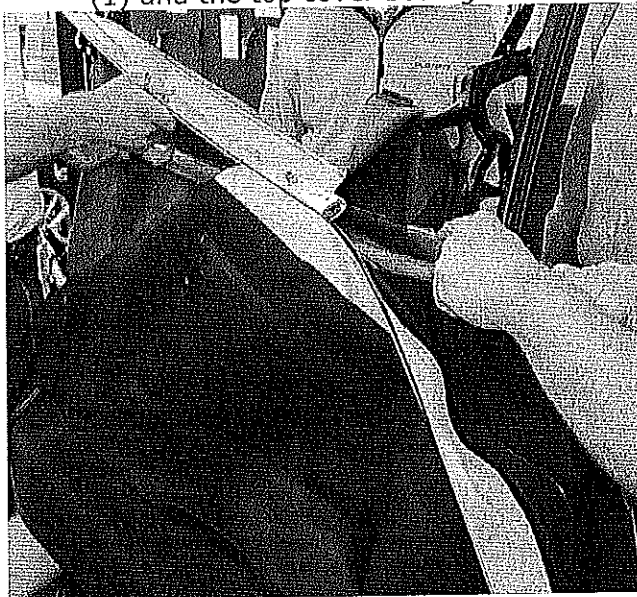
19. Slide the reworked #2 bow onto the headliner and new top cover beads **at the same time** as shown above.

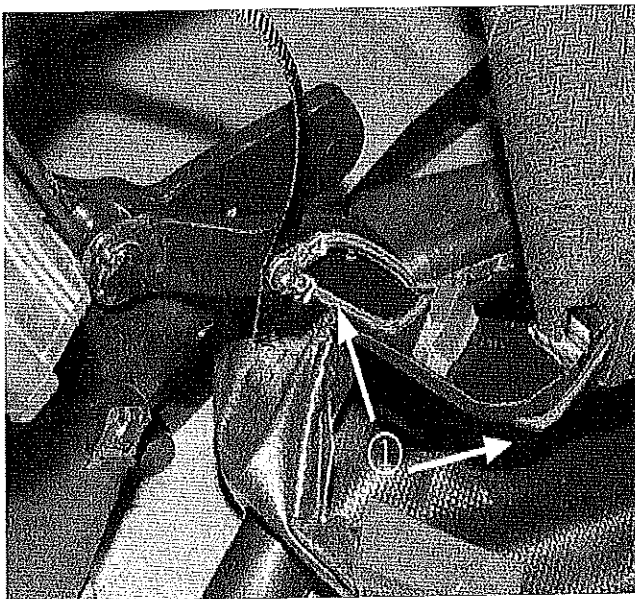
**Important:** Ensure that the top cover #5 bow bracket cord (1) is routed underneath the bracket.

23. Rivet the new top cover #5 bow bracket cord (1) to the new holes on the left and right #5 bow brackets, along with the water bag cord and the headliner control strap as shown above.
24. Install the rear window pivot bracket nuts, connect the defogger connectors, reinstall the headliner bead around the rear window, and secure the top cover to the #5 bow. Refer to Folding Top Cover Replacement in SI.
25. Reroute the side tension cables through the rear side rail, rear weatherstrip and top cover on each side following the steps below. If additional detail is needed, refer to Folding Top Cover Side Tension Cable Replacement in SI.

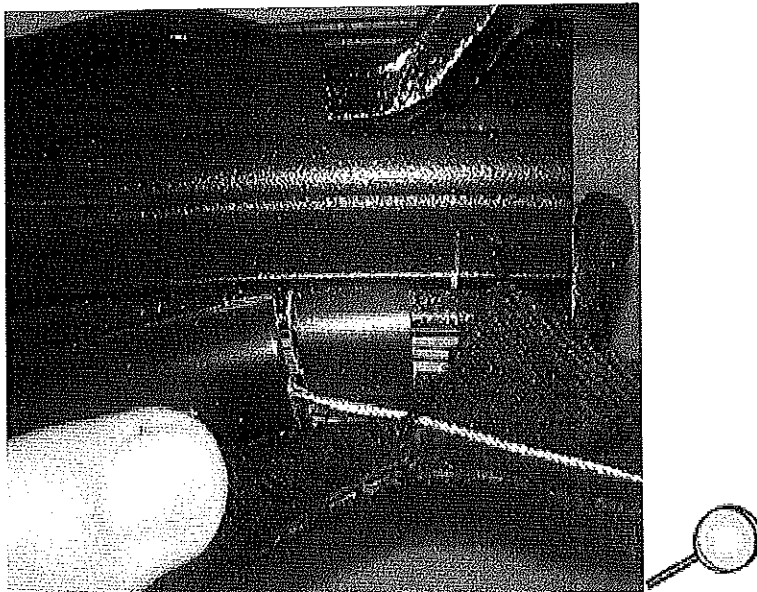
**Note:** The design of the top cover plastic retainer has changed slightly on the new corded top covers. The plastic retainer on the previous top covers had a slit near the end that allowed the side tension cable to pass through it as shown above.

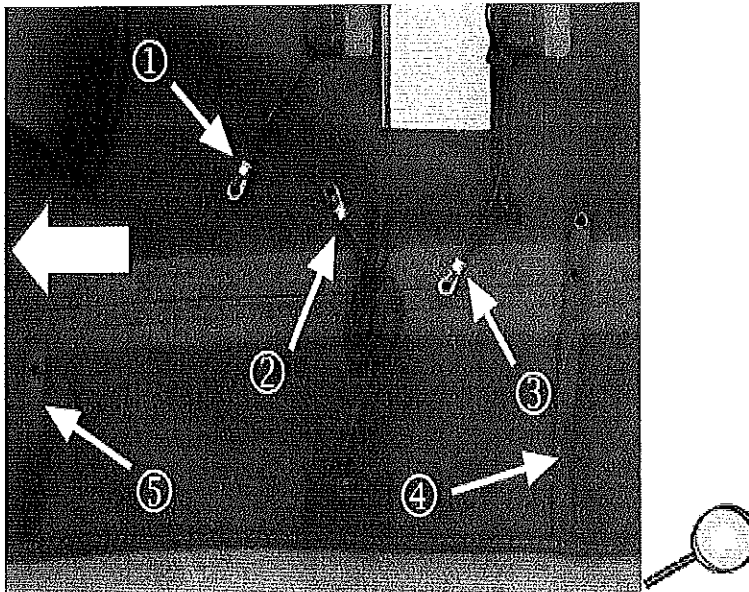
**Note:** The three cords added to each side of the top cover are color-keyed with paint dots on the cord eyelets. The orientation of the three colors white (1), yellow (2) and orange (3), along with the rear (4) and front (5) control straps, are shown above. The following steps will reference them as the white, yellow or orange control cords.

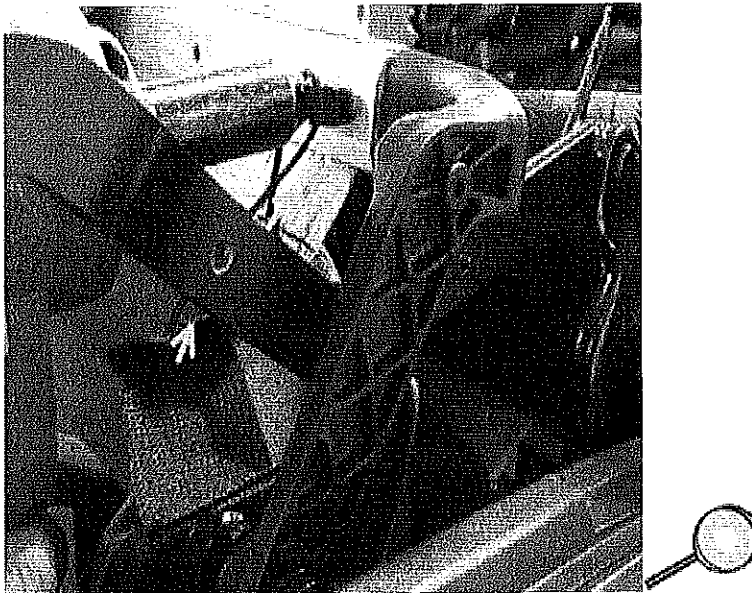
28. Rivet a new P-clip to the inboard hole of the #2 bow bracket on the left and right sides following the steps below:

**Note:** The **headliner** cord end eyelets will be riveted at a later step. They can hang off the top side of the P-clip for now.

- 28.1. Route the cord (no color dot) coming off the **headliner tab** upward through the bottom of the P-clip. Position the clip to the #2 bow so that the P-clip is facing outboard.

**Note:** The headliner control cord must be routed through the P-clip before installing the rivet.

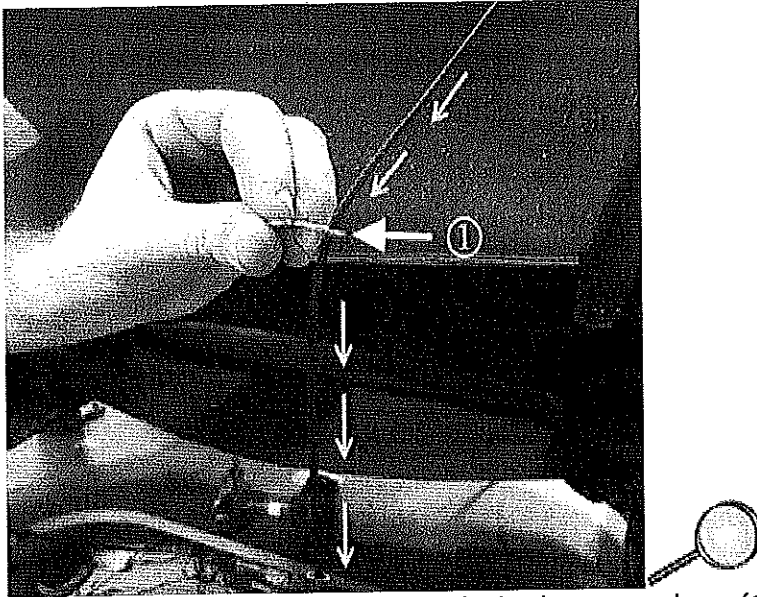
- 29.2. Route the cord downward through the large eye loop (1) with the eye loop angled downward as shown above.

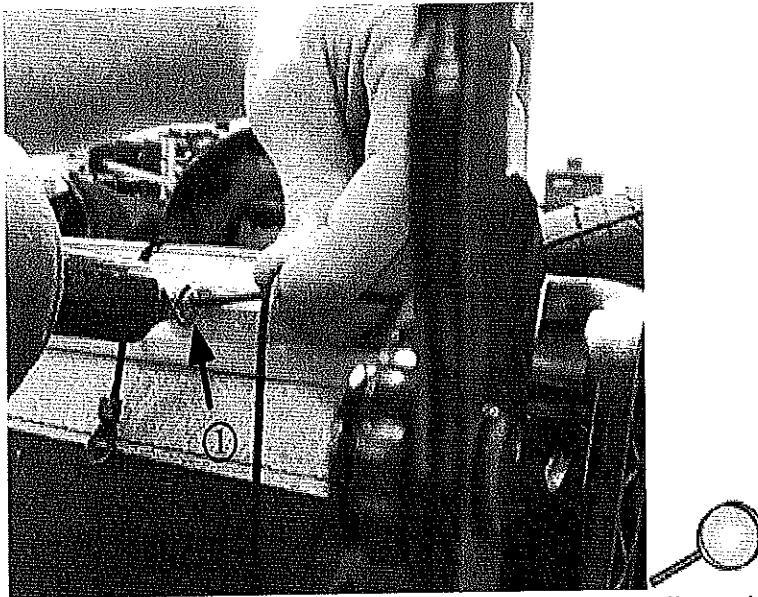
- 29.3. Install the rivet on the #2 bow through the small eye loop hole with the large eye loop hole (1) aimed outboard as shown above.

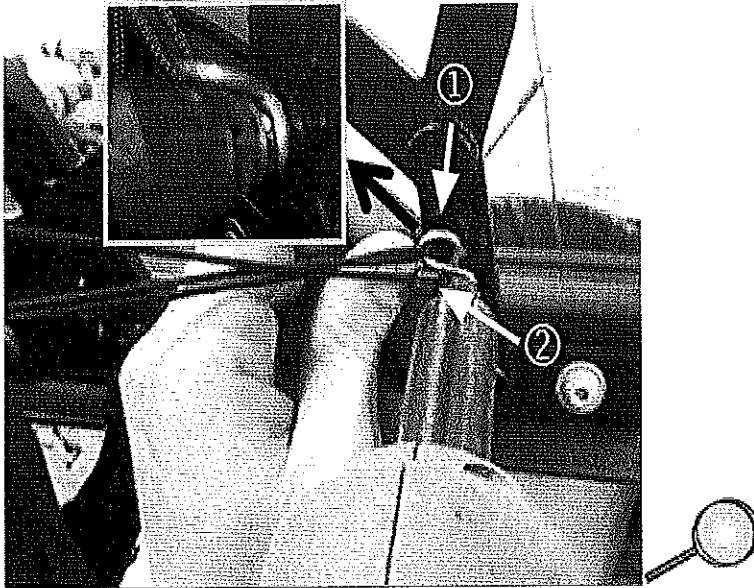
**Note:** The large eye loop should already have the yellow and orange control cords routed through it, prior to attaching the rivet.

30.3. Install the rivet to the rear #1 bow link with the 75° bend of the large eye loop angled inboard (as shown in the inset above) and the orientation of the eye loop (1) and the cord eyelet (2) as shown.

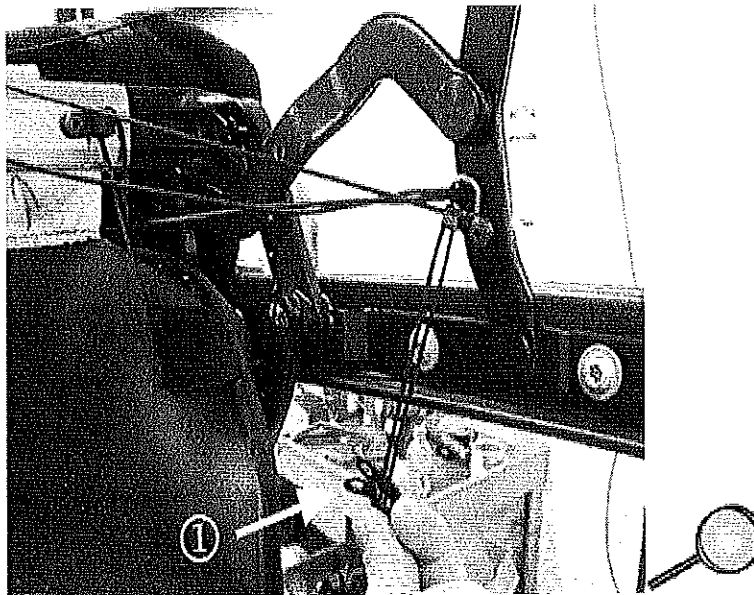
31.1. Grab a new P-clip (1) and route the yellow and orange control cords through the P-clip as shown above.

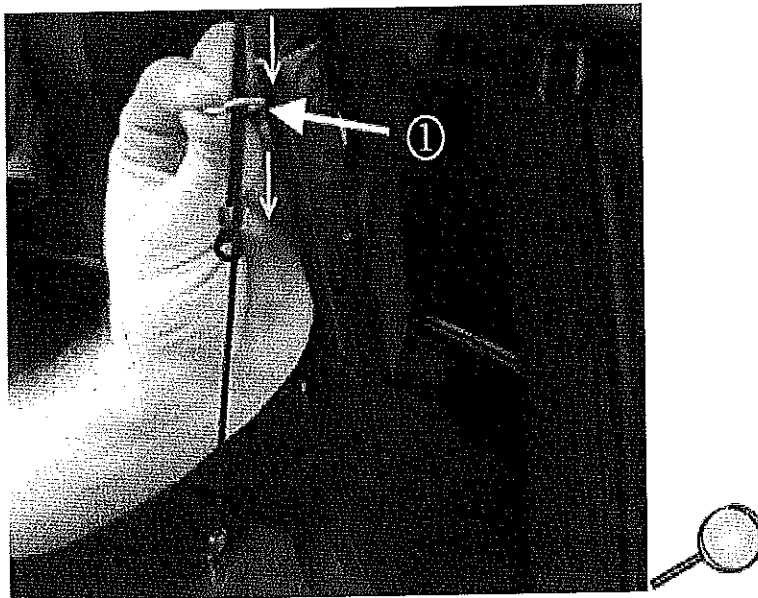
- 32.1. Route the yellow and orange control cords down through the large hole in a new eye loop (1) with the eye loop angled upward as shown above.

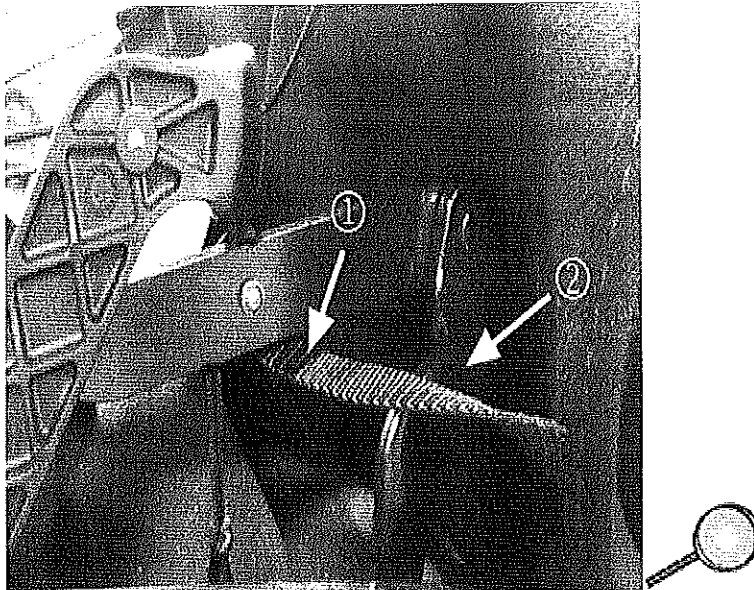
**Important:** Verify that the rear strap (1) of the top cover is routed under the side link and is not hung up behind, but is clear of, the wishbone link (2) as shown above.

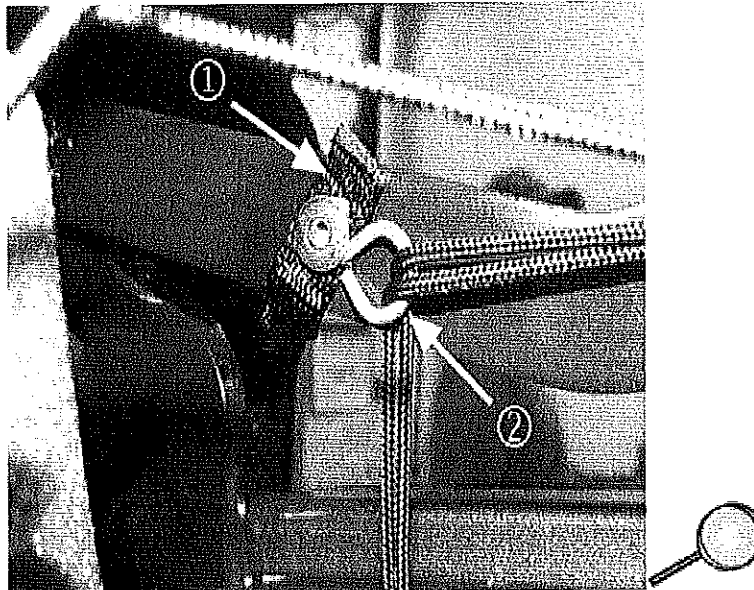
32.2. Insert a new rivet through the small opening in the eye loop (2), then through the strap (1) with the orientation of the eyelet and the strap as shown in the graphic above.

**Note:** The large eye loop should already have the yellow and orange control cords routed through it prior to attaching the rivet. Also ensure that the cover strap is oriented straight down and under the link and not angled forward or rearward.

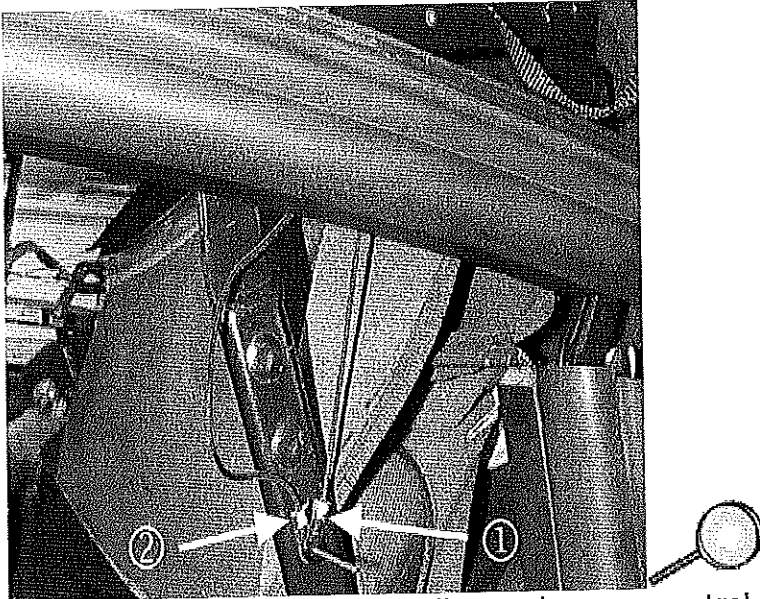
33. Rivet both end eyelets of the yellow and orange control cords to the hole previously drilled in the left and right balance links following the steps below:
- 33.1. Insert a new 3.2 mm (0.125 in) rivet through the end eyelets on first the yellow (1), and then the orange (2), control cords.
  - 33.2. Attach the rivet to the hole in the balance link as shown above.
  - 33.3. Repeat the same operation on the opposite side.
